*T h e*  
**California Earthquake**  
**of 1906**

*Edited by*  
**David Starr Jordan**

# The Destructive Extent of the California Earthquake. Its Effect Upon Structures and Structural Materials Within the Earthquake Belt

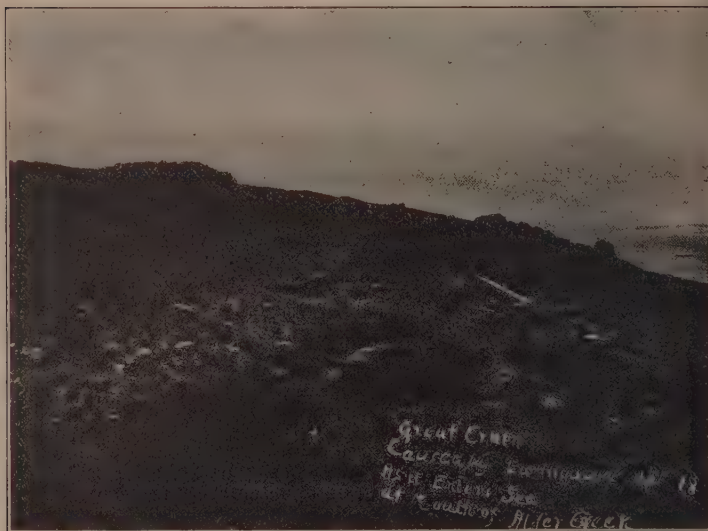
*Earthquake Rift, As It Comes up from the Sea at Point Arena, Mendocino County.*

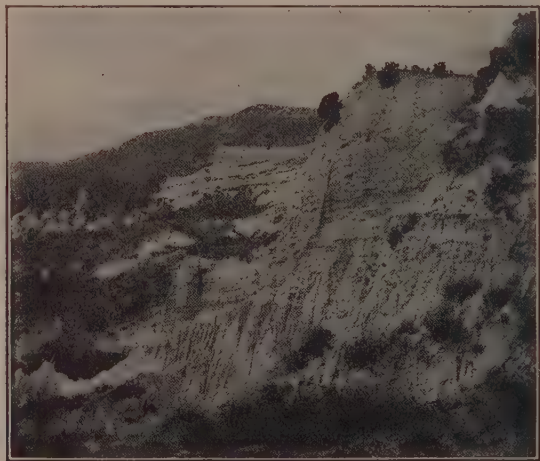
*Fissure and Landslip, San Jacinto Valley, 1897.*

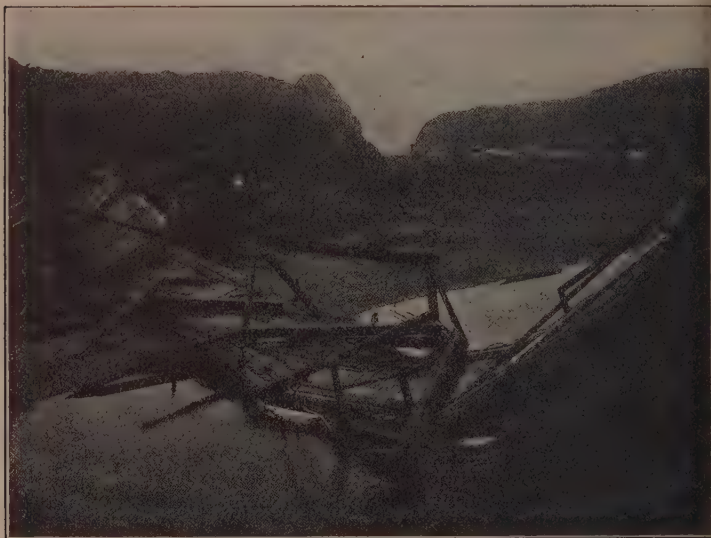
*Alder Creek Bridge, Mendocino County. The Earthquake Rift Is near the Middle of the Picture.*

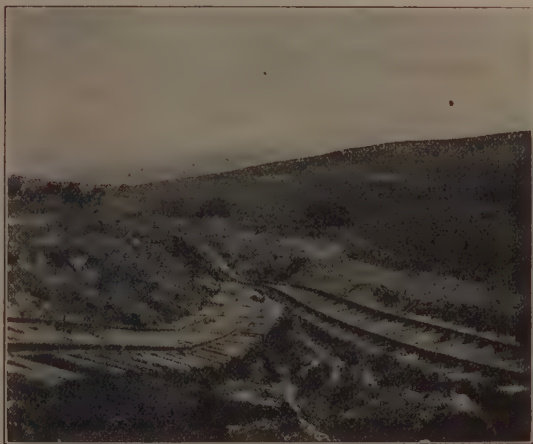
*Tomales, Marin County. The North Shore Railroad and the Earthquake Rift.*

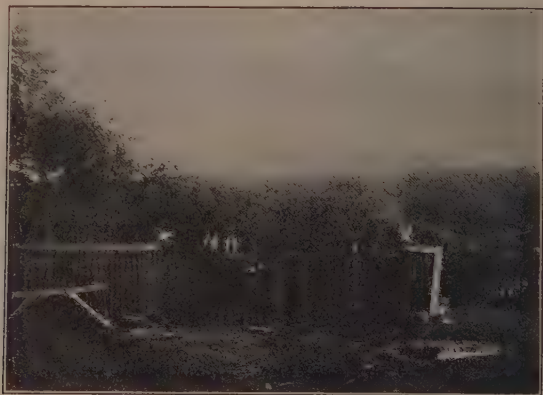
*Point Arena. Picket Fence Was in One Continuous Line. Photograph Shows Short Section Put in to Fill up Offset by Land on the West Side.*

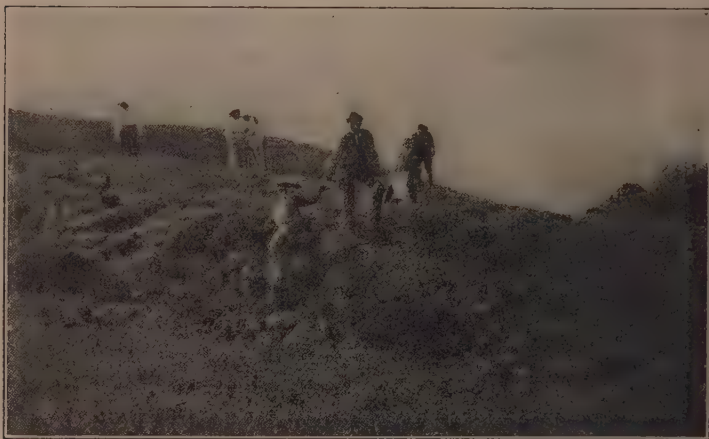
*Landslip at Sobrante.*

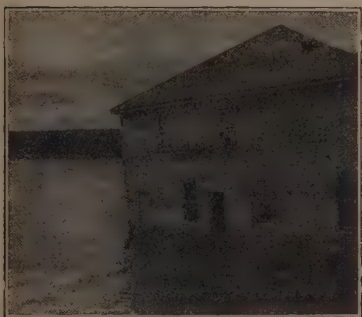
*Marshall Hotel, Thrown into Tomales Bay.*

At Marshall the humble hotel was thrown bodily—and upright—into the bay, the boarders unharmed; and at aristocratic Inverness, on Tomales Bay, three summer cottages suffered the same fate. A fisherman in the bay reports that the waters of Tomales Bay receded, leaving his boat in the mud.

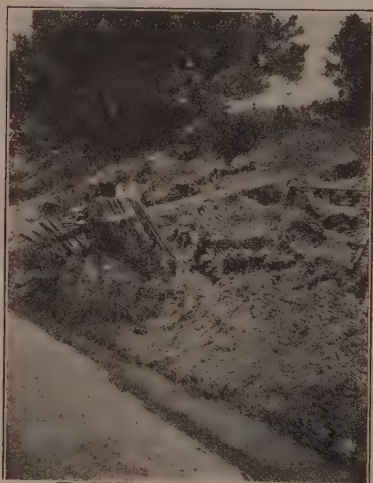
*Earthquake Crack in Country Road from Olema to Point Reyes.*

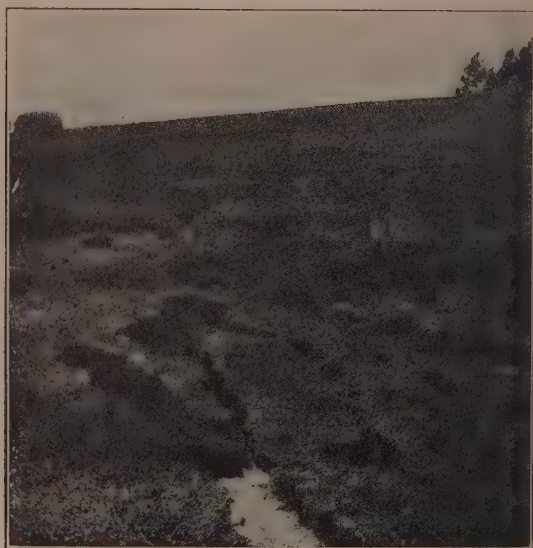
*Earthquake Rift, Freeman's Ranch.*

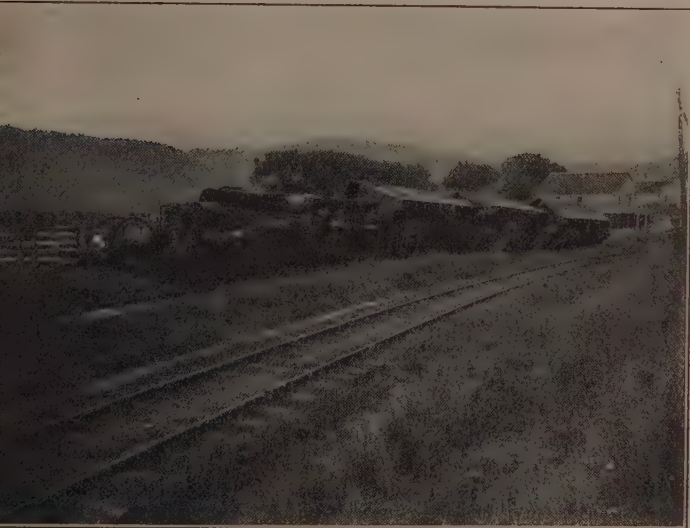
*Train Overturned by Earthquake, Point Reyes Station, Marin County, Cal.*

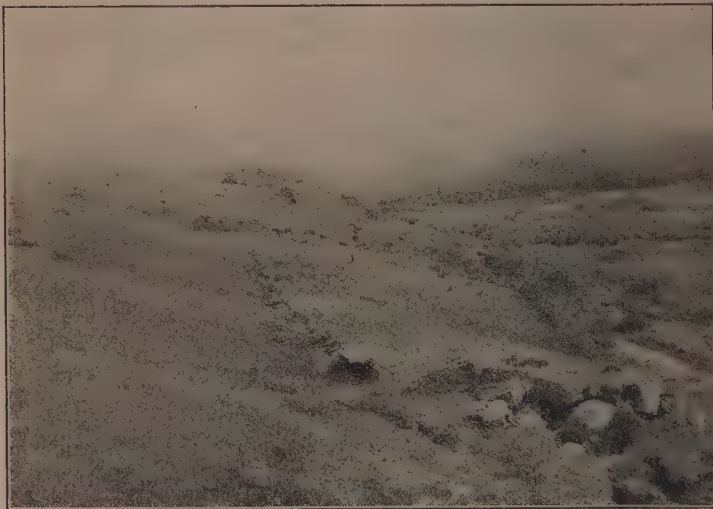
*Earthquake Rift, Olema.*

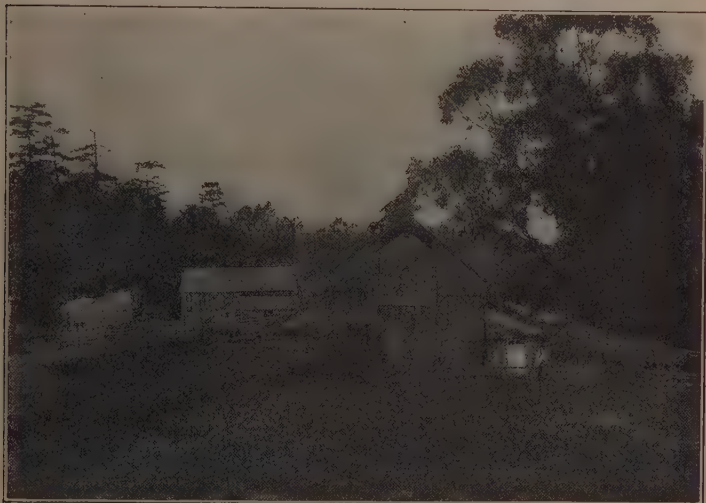
hours to get the frightened cattle back into the 'corral.' The stone steps to the basement of the dairy, on the east side of the crack, now stand sixteen feet seven inches to the southward of the door to which they led. About Skinner's, line fences and water pipes crossing the fault were broken, a break of sixteen and one half feet being left

*Skinner's Ranch, Olema.*

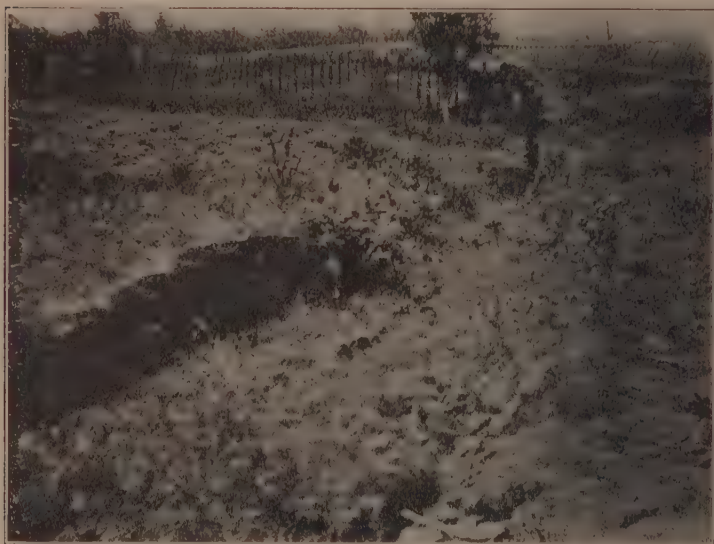
*Earthquake Rift, Morrill's Ranch, Skylands, Santa Cruz County.*

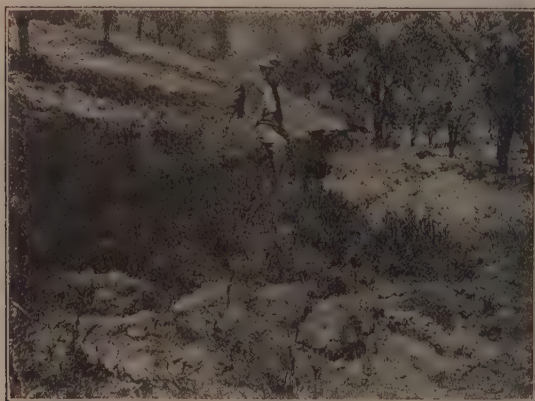
*Earthquake Rift, Morrill's Orchard, Santa Cruz County.*

The earthquake ripped its way through the orchard, shifting the rows of trees six to eight feet and treating roads and fences in the same reckless fashion. The large hospitable Morrill farmhouse stood partly over the track and was split in two and utterly ruined. Farther on at Skylands, on the ridge of the mountains, Fern Gulch was filled with wreckage; redwood trees four and five feet through, two or three hundred years old, were snapped off like

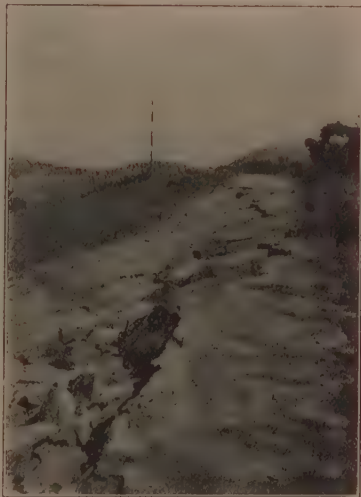
*Inverness Road, near Olema, Marin County.*

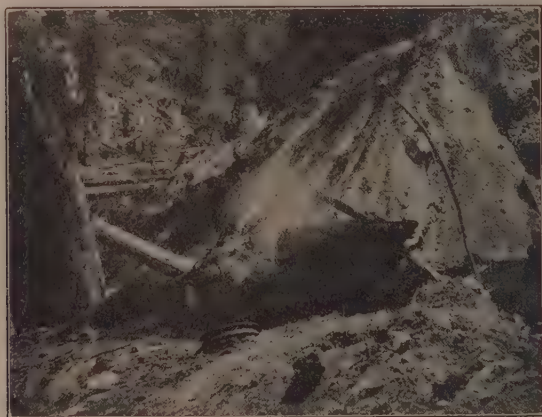
whip-lashes. The rift crossed Hinckley's Gulch at right angles. This is a narrow gorge about a hundred feet deep, in which stood the large Loma Prieta sawmill. The gorge was filled by landslips thrown from both sides. The mill was completely buried, with nine mill hands, and a redwood tree over a hundred feet high was set erect and unhurt over the place where the mill stood. The bodies of six men were recovered. One of these, the foreman, was found erect, smothered in mud, but standing with extended arms and limbs in the act of running from the mill. With him, equally erect and in the act of running was the body of a Siberian mastiff. Their position marked the meeting point of the two walls of the cañon. The crack went on across the hills, always in the same direction, southeast by south, till it came to the Chittenden Ranch in the Pájaro Valley. Here it tore off the hillside,

*Wreck of Loma Prieta Sawmill, Hinckley's Gulch, Santa Cruz County.*

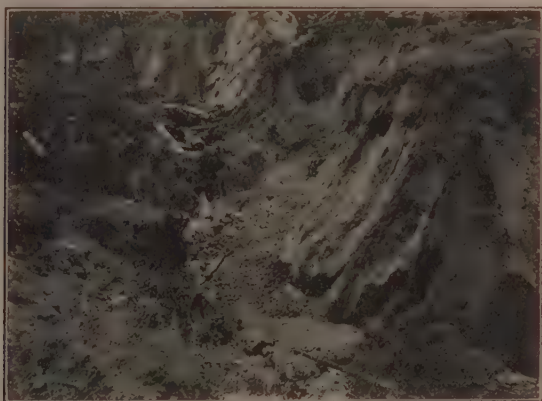
*Site of Loma Prieta Sawmill, Covered to the Depth of 125 Feet.*

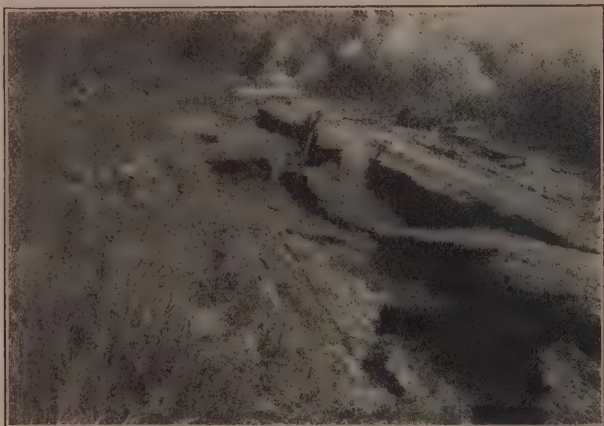
*Slump in Soft Ground, Milpitas.*

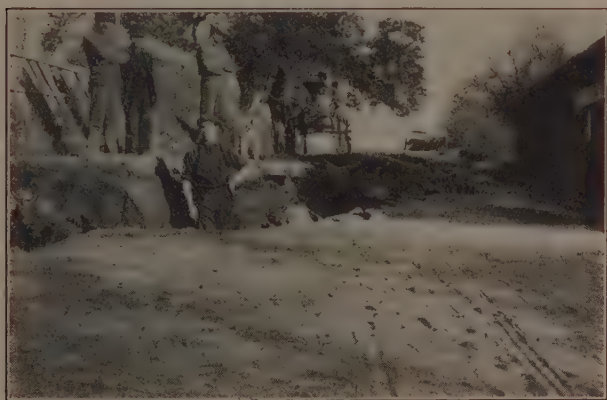
*Rift Crossing Road near Skylands, Santa Cruz County, Showing  
Relative Sinking of West or Uphill Side of Rift.*

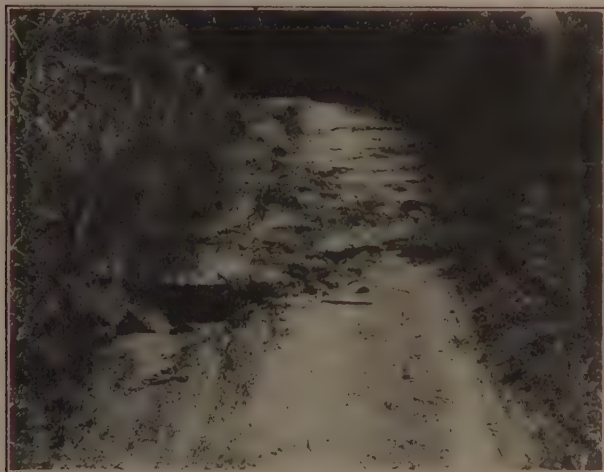
*Rift Across Road near Azul Springs, Santa Clara County.*

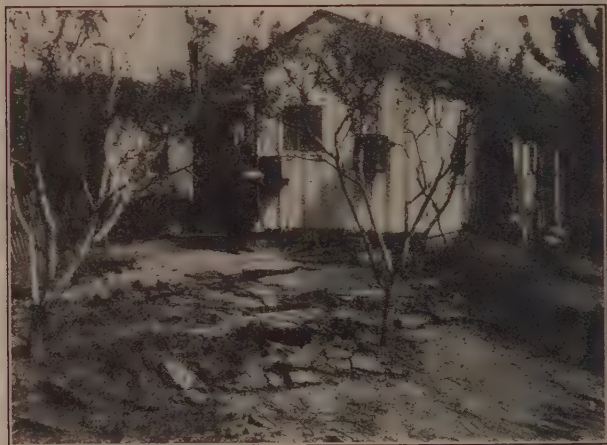
*House over Rift near Saratoga Springs, California.*

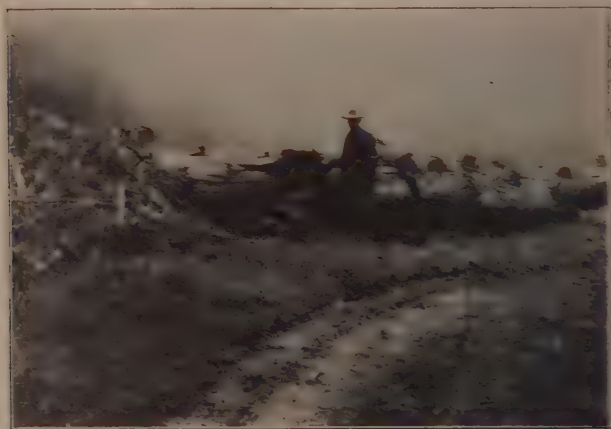
*Redwood Snapped Off by Earthquake near Fort Ross, Cal.*

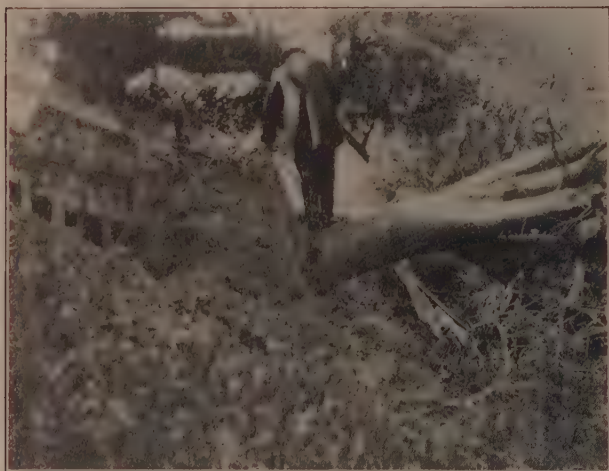
*The Fault Passes Under a Live Oak and Uproots It, Woodside, Cal.*

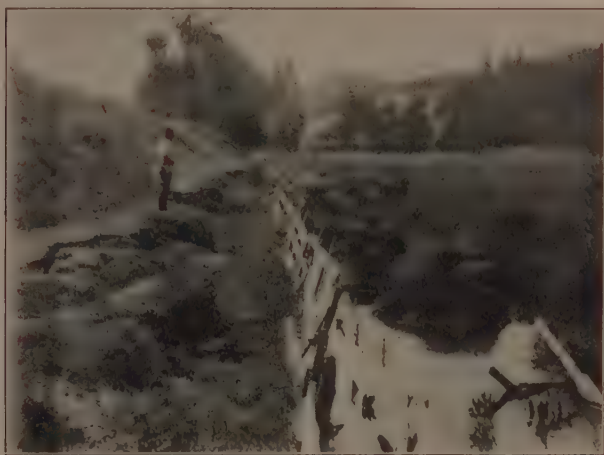
*Rift on Shafter's Ranch, Olema, Cal.*

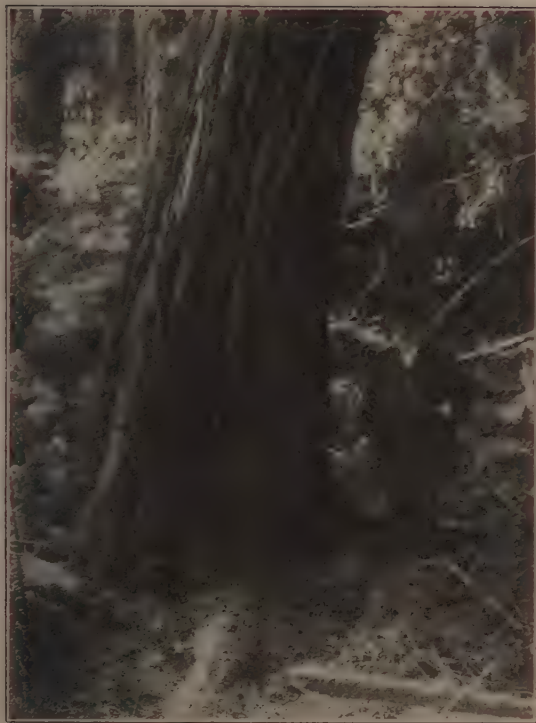
Referring again to Fig. 2, we note that the rift disappears in the ocean at the extreme north a few miles above Point Arena at the mouth of Adler Creek. From Adler Creek the fault may be followed southward approximately parallel to the coast line to Fort Ross, where it runs into the ocean about  $2\frac{1}{2}$  miles south of the fort. Earthquake vibrations were very severe in the neighborhood of Fort Ross, I believe more severe than in the vicinity of San Francisco, but there were no important human structures to demolish. Fig. 3 shows a redwood tree about six feet in diameter which happened to stand right on the fault line near Fort Ross. It was split into halves for a distance of 35 feet upward from the ground. The westerly half was sheared toward the north and actually moved past the east half a distance of about 8 inches. Fig. 4 shows a pine tree which was situated a few feet to the east of the fault line. It was thrown so that it leans toward the east. It was somewhat cracked at the base and its roots on the west side were torn, due to the shearing action along the fault line. The tree was subjected to torsion because it had roots on both

FIG. 3—Redwood Tree, Situated on the Fault Line, near Fort Ross,  
Sonoma County, California.

sides of the fault, which explains the cracking at the base of its trunk. Many trees were more or less ruptured along the fault where the line traverses timber growths; and in one place I observed leaning redwood trees for a con-

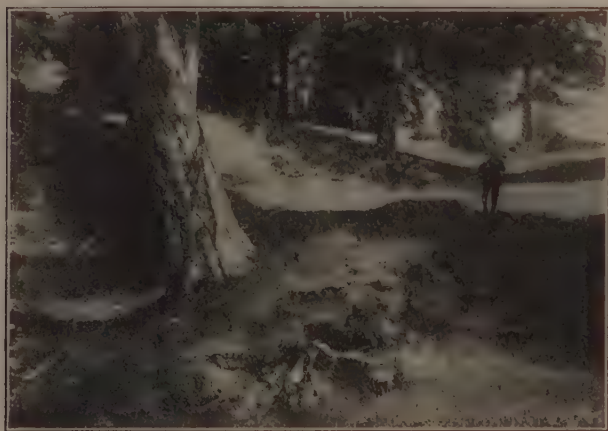
FIG. 4—Pine Tree Standing on the Line of Fault near Fort Ross, Sonoma County; the Ruptured Surface Shows the Characteristic Appearance of Newly Plowed Ground.

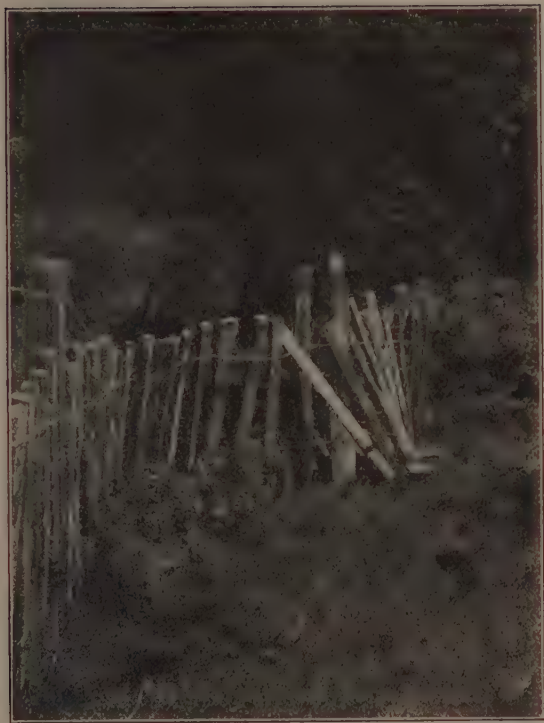
FIG. 5—Fence near Fort Ross, Sonoma County, California, Offset Nine Feet at the Line of Fault.

the resulting displacements mentioned. The tearing of the surface along the fault also clearly shows that there was some torsion in a clockwise direction when the eye looks downward. Fig. 5 shows a fence one-half mile south of Fort Ross which did not collapse, but was curved and bent to suit the lateral movements of the earth, so that its unmoved parts are now nine feet out of alignment. A second fence one-half mile farther south completely collapsed for a few feet on each side of the fault and was offset fifteen feet six inches. Near the head of San Andreas Lake a fence, Fig. 6, was offset seven feet. A roadway in the Point Reyes locality was dislocated about twenty feet. In all cases the west side moved north.

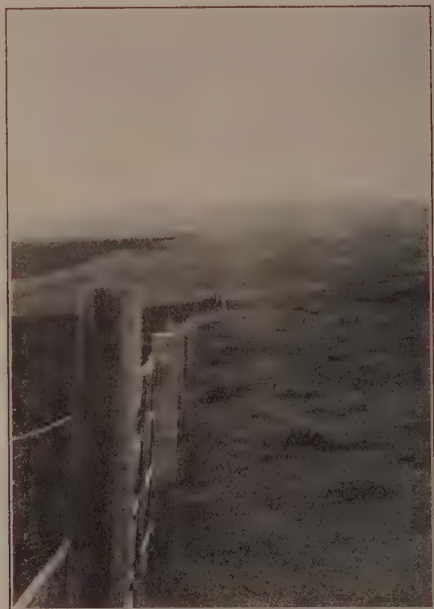
FIG. 6—Fence near the North End of San Andreas Reservoir, San Francisco Peninsula, Offset Seven Feet at the Line of Fault.

compensating places the pipe was telescoped by similar amounts. Fig. 34 shows a break in this pipe line near the up-stream end of San Andreas Lake. The pipe at this point was pulled apart  $53\frac{1}{2}$  inches. A property fence, Fig. 6, which crossed

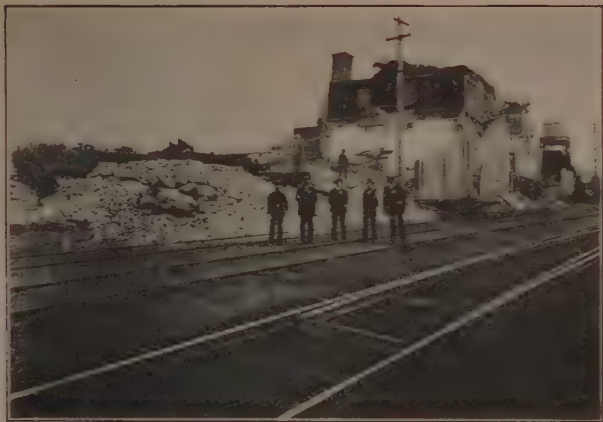
How then should the general destruction be explained? The brick buildings of Santa Rosa were carelessly constructed. Lime mortar was almost invariably used with bad brick bond. The sand of the lime mortar used was what is locally known as "drift" sand, containing, according to a local engineer, practically fifty per cent of loam. When we remember that it has been too common a custom in California to lay brick for small structures without sufficiently wetting them, in fact almost dry, what else should be expected, especially when we further observe a most inadequate anchoring of the floor and roof frames to the outer walls, and a usual absence of necessary cross walls or frames. Besides brick buildings are not capable of withstanding heavy earthquake vibration. It is a fault of design more than of workmanship. Upon this

FIG. 7—Santa Rosa Flour Mill. A Typical Brick Structure with Wooden Interior, Three Stories in Height; the Major Portion Completely Collapsed.

Figures 7, 8, 9 and 10 show typical views of earthquake and fire destruction in Santa Rosa.

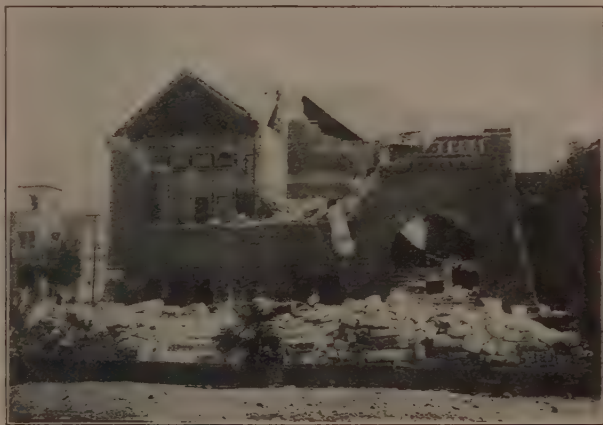
FIG. 8—Carnegie Library, Santa Rosa. A Typical Brick Building with Wooden Interior Framing; the Outer Walls Faced with Cut Stone. Buildings of This Type of Construction Invariably Were Shattered near the Roof Lines. The Picture Is Representative of the Behavior of Stone-faced Buildings with Inadequate Wood Framing.

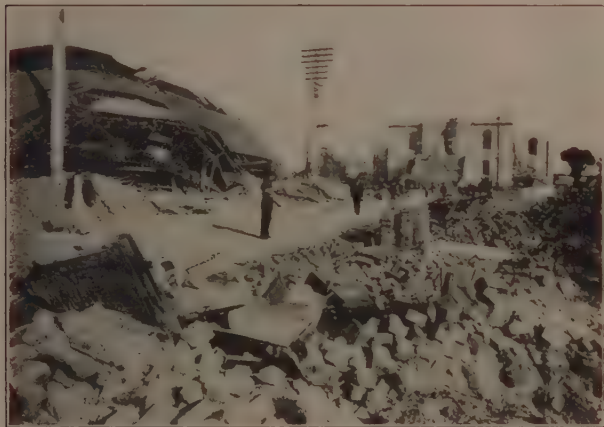
FIG. 9—A Scene in Santa Rosa Photographed Shortly after the Earthquake and Fire. The View Shows the Corner of Fourth and Mendocino Streets. The Ruins of the Court-House face Mendocino Street. On the Left in the Picture Is Seen the Collapsed Keegan-Brush Building, a Two-Story Brick and Stone Structure, Devoted to General Store Purposes. This Building Did Not Burn, and Ninety Per Cent of the Stock Was Saved. On the Right Side of Mendocino Street the Fire Destroyed Everything. In This Respect the Picture Is Instructive in That It Shows the Difference in the Destruction by Earthquake and Fire.

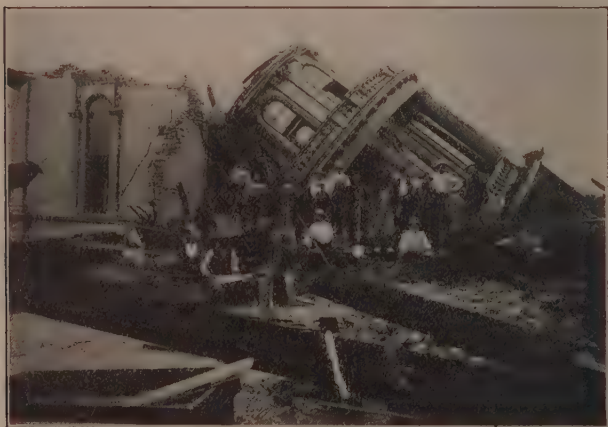
FIG. 10—*The Collapsed Court-House Dome, Santa Rosa. The View Is Taken with the Camera on the Second-Story Roof; See Fig. 9. The Court-House Consisted of Three Stories of Brick, the Third Story Smaller in Plan Than the Other Two. The Third Story Supported the Wooden Dome.*

the water works system, its artesian sources of supply, or its pumps. A few house-service pipes broke at the house lines. No sewers were crippled. It is plain to me that there was little or no unequal resultant movement of the ground at Santa Rosa such as one finds at the fault line. The destruction was due merely to earth vibration and the brick

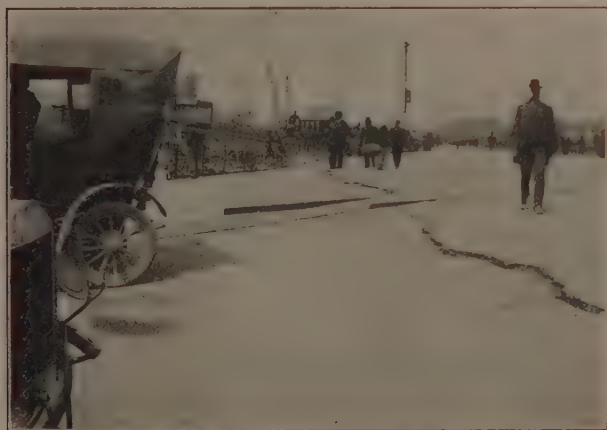
FIG. 11—*Street Surface in Front of the Ferry Tower, Showing Undulations and Cracks in the Asphalt Pavement.*

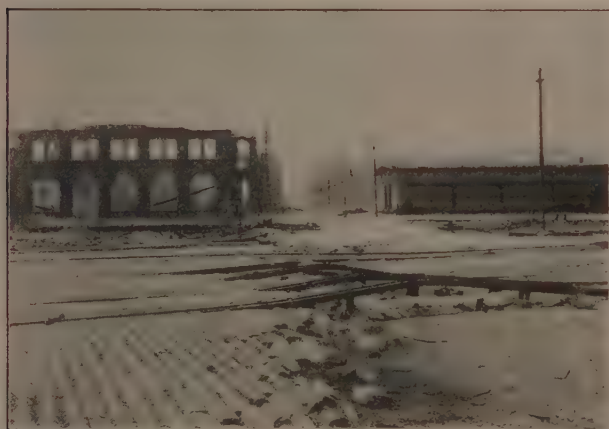
FIG. 12—Rupture of Car Tracks and Pavement on East Street,  
Corner of Pacific Street.

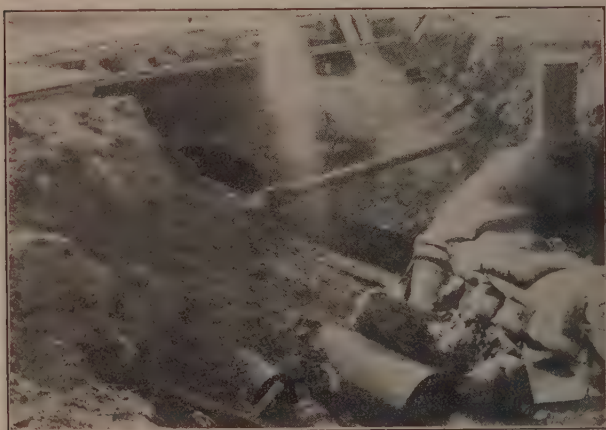
FIG. 13—Scene Corner of Howard and Seventeenth Streets Showing Rupture of Car Tracks, Sewer, Water and Gas Pipes.

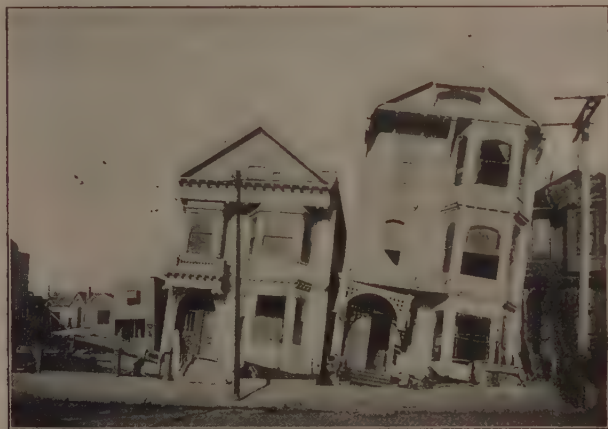
*FIG. 14—Collapsed Frame Houses on Howard Street, between 17th and 18th Streets. The One on the Left Is Completely Razed. At This Place the Earth Movements Were Especially Severe, and Even Good Construction Would Have Suffered.*

Many frame buildings collapsed on the filled ground, Fig. 14; and an unreasonably large number on the more substantial areas of the city. Some of the destruction in the made land district was unavoidable, but much of the general collapse of frame houses was due to improper underpinning in the foundations. Such houses virtually stood on stilts; consult Figs. 15 and 16. Moreover, the cheaper frame buildings were provided with carelessly constructed brick chimneys built with weak lime mortar; naturally the brick work cracked to pieces. It is therefore easy to see why so many of these houses burst into flames immediately after the earthquake. It is said that fifty-seven fire alarms were sent to the Fire Department within the first half hour. Of course not all of these fires were produced by fallen or cracked chimneys in frame buildings. Some were similarly started in cheap brick structures, which are just as readily inflammable,—and still others by the breaking of electric wires of high tension, or through improper electric insulation of power wires.

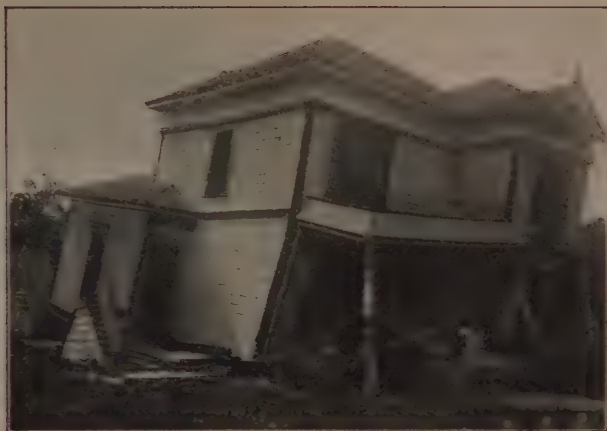
FIG. 15—Frame House Wrecked in Santa Rosa: Due to Weak and Decayed Underpinning.

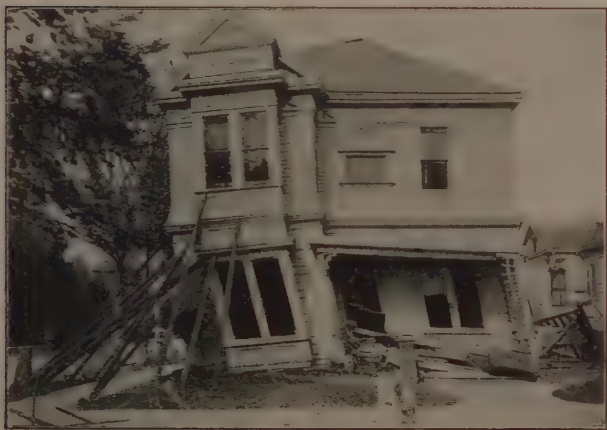
FIG. 16—Collapsed Frame House in San José Showing the Effect of a Lack of Transverse Framing and an Absence of Continuity in the Vertical Sticks at the Floor Levels.

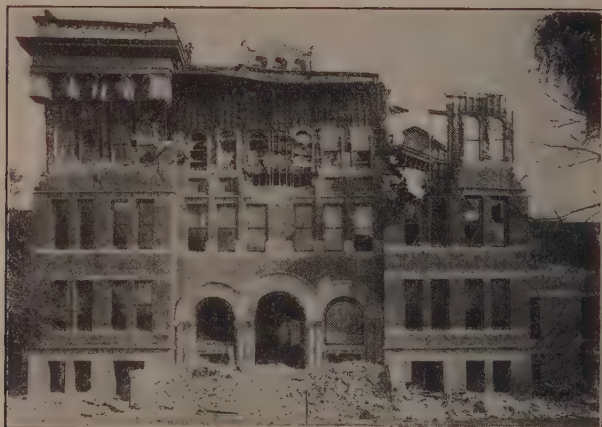
FIG. 17—*A San José High School. Ordinary Brick Construction with Wooden Interior.*

least every other joist of the floor system ought to be carefully tied to the outer brick walls. The roof similarly should be anchored to the walls; and its main trusses should have properly designed lower chord tie rods, and not depend for their resistance to spreading upon the stiffness of the side walls of the building. Foundations of these structures should also be made with great care to have them act as units to prevent unequal settlement.

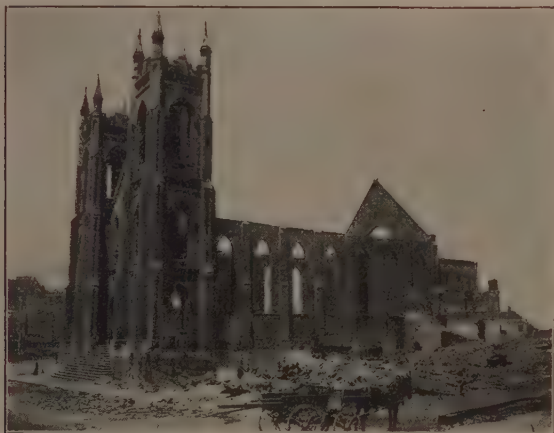
FIG. 18—*St. Francis Church, San Francisco; an Example of Excellent Brickwork.*

damage. I refer to several churches, see Fig. 18, to the Custom House or Appraiser's Building and to the Palace Hotel. The walls of the Appraiser's Building were thirty-six inches thick. The Palace Hotel was built immediately after the earthquake of 1868 and was intended to be earthquake-proof. The outer walls were most carefully designed, the window openings were crowned with arches and

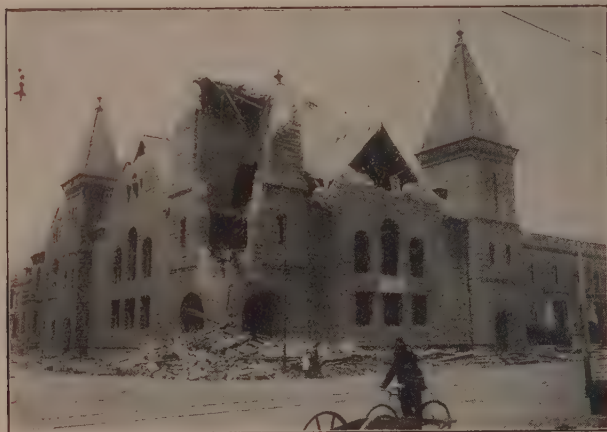
FIG. 19—First Baptist Church, Oakland, California. The Dangerous Tower Was Pulled Down Several Days after the Earthquake.

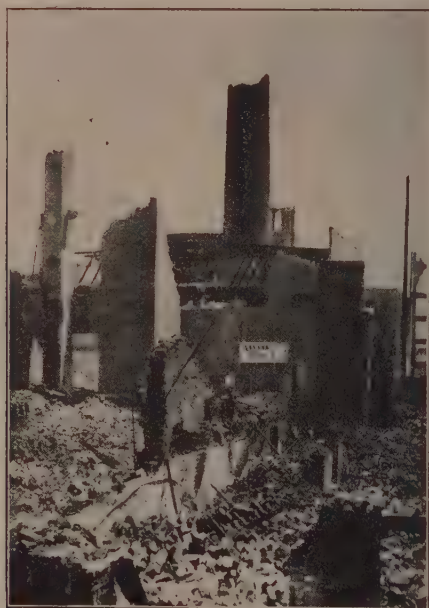
Chimneys in San Francisco were built of brick and very often without cement in the mortar. With few exceptions the chimneys were thrown down by rupture within the middle third of the height. A number of lives were lost by falling power house chimneys; see Fig. 20. In the future I believe chimneys should be built of reinforced concrete and not of brick. Where brick is insisted upon, the bond should be carefully provided for, the mortar should be rich in cement and there should be some metal reinforcement.

FIG. 20—Fire Ruins of a Power-House of the San Francisco Gas and Electric Company, Station C. The Chimney of This Structure Fell During the Earthquake Shock, Demolished a Part of the Equipment and Killed One Person.

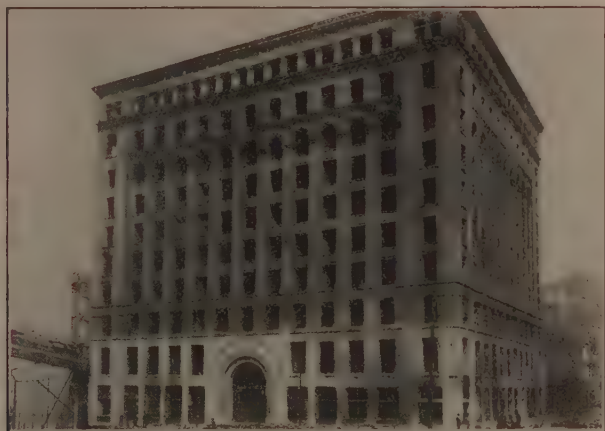
certainly should not advocate self-supporting walls for earthquake countries. The Mills Building in San Francisco, Fig. 21, an otherwise excellent structure of ten stories, was designed with self-sup-

FIG. 21.—The Mills Building, San Francisco; Self-Supporting Brick Walls, Interior Framing of Steel, Floors and Partitions of Hollow Tile.

porting walls and with main columns breaking joints at every floor level. After the earthquake the walls of this structure leaned from seven to nine inches into Bush Street. While the structure did not appear to be severely racked by the earthquake, the fact that the walls bore little relation to the interior frame, and the interior frame lacked continuity of columns at every floor, would not lead

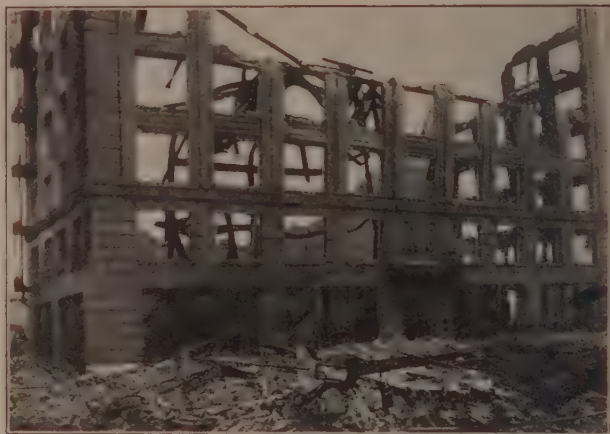
FIG. 22—Fire Ruins of the Cowell Building, a Class B Structure, Showing the Great Destruction by Fire.

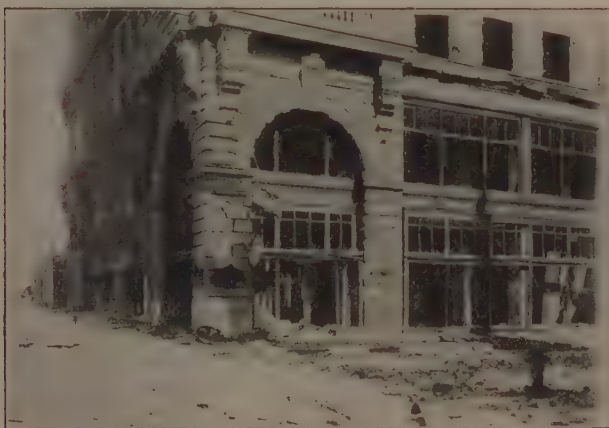
FIG. 24—Flood Building, Northwest Corner, Showing Heavy Earthquake Cracking of the Sandstone Masonry Enveloping the Steel Corner Column.

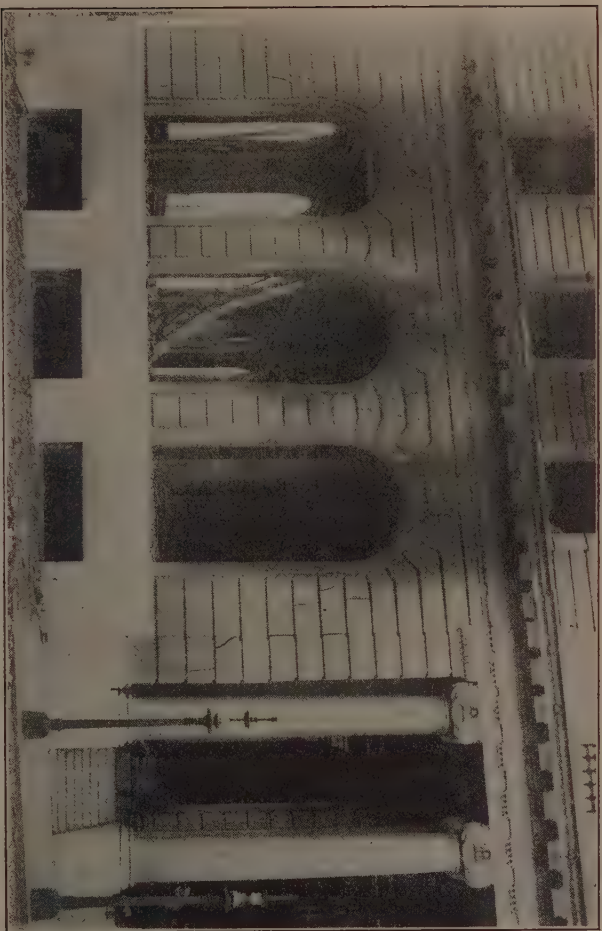
FIG. 25.—St. Francis Hotel, Southeast Corner, Showing Heavy Earthquake Cracks in the First Story of the Sandstone Front.

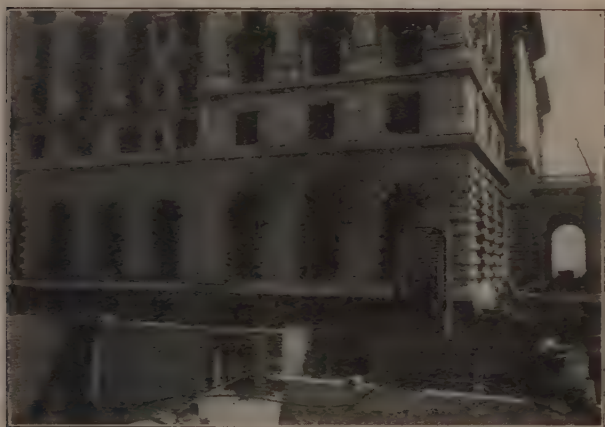
In Class A structures terra cotta was very generously and profusely used for ornamentation on the facing of the curtain walls of the street fronts. Being a material of the same nature as hollow tile, it is brittle and lacks toughness. It was generously spalled by earthquake vibration, and, while I by no means wish to imply that its use should be prohibited, I think it should be very carefully selected, be well burned, be used with greater thickness than in the past, and the hollows in the blocks should be filled. Highly ornamented terra cotta should be discouraged. The earthquake produced considerable spalling in the terra cotta of the Mills Building, and very generally damaged the terra cotta face of the Fairmont Hotel, especially on the north front (Fig. 26).

FIG. 26—*Fairmont Hotel; North Front, Showing Earthquake Cracks in the Terra-Cotta Veneer of the Second Story Walls.*

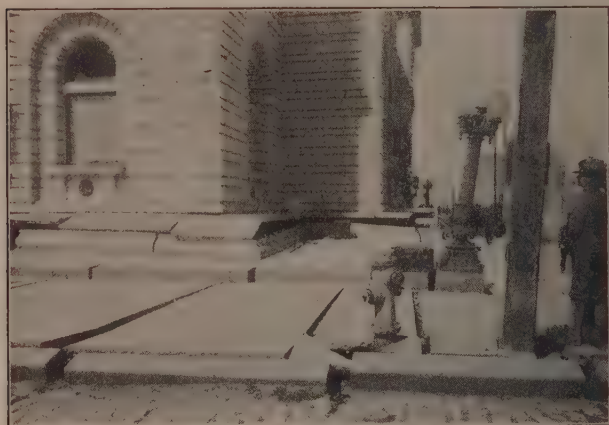
Important structures should not be built on treacherous ground. The site of the general Postoffice (Fig. 27) was very unhappily chosen. That

FIG. 27—General Postoffice, Southwest Corner, Showing Severe Distortion and Subsidence of the Sidewalk and Street Levels.

building, while exceedingly well built, rests on filled ground, and under its southwest end ran an arm of the Mission Creek. In this vicinity the ground was very much disturbed, and the street fell away from the building. The structure, while it stood and was saved from fire, was severely racked, and its beautiful granite fronts were badly

cracked on all sides. The interior partitions of the building were of double hollow tile, and were greatly destroyed. The structure represents an example of a building with heavy masonry walls with a partial and too light a steel frame. Con-

sidering the material upon which it rests, the building withstood the earthquake surprisingly well.

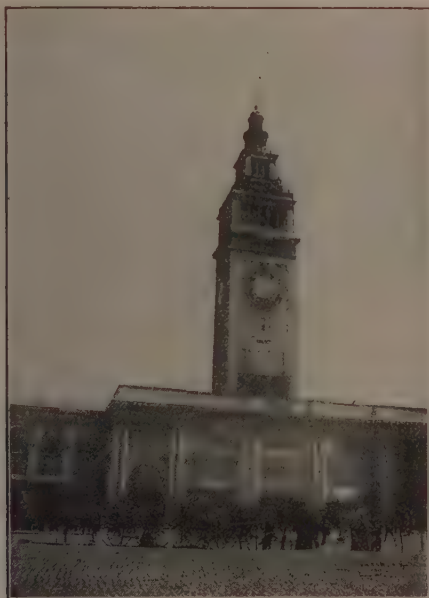
diagonals should have been heavier, and of stiff sections instead of rods. Some of the diagonal rods were snapped and some gusset plate connec-

FIG. 29—*The Ferry Tower Shortly after the Earthquake.*

tions and riveted joints were ruptured. I have already referred to the superior merit of quadrilateral framing, using spandrel girders and knee bracing. The tower was rapidly dismantled, the

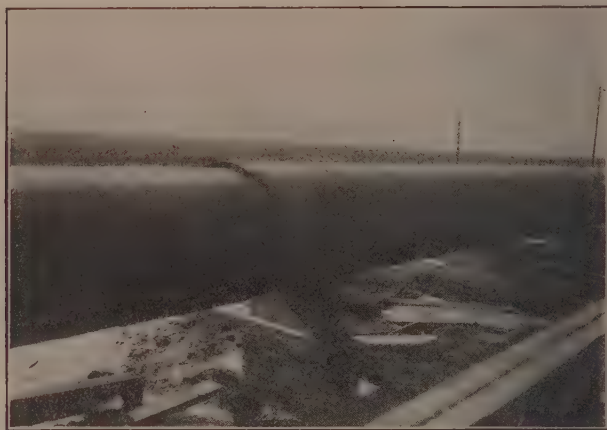
FIG. 31—Rupture of the 44-inch Crystal Springs Conduit on the San Bruno Marsh; Picture Taken May 2, 1906. The Wooden Supports under the Pipe Are Temporary Forms Built after the Catastrophe. The Pipe Has Been Straightened Preparatory to Repairing the Transverse Riveted Joints.

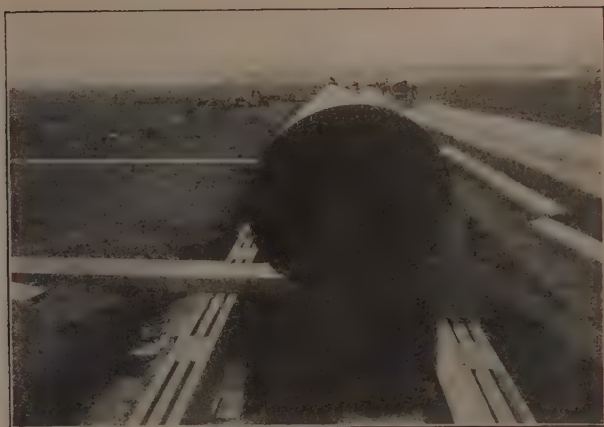
FIG. 32—Rupture on Crystal Springs Pipe Line, San Bruno Marsh.

exhibits a view of one of the ruptures on the San Bruno marsh. Figs. 32 and 33 show other scenes along this pipe line during the period of repair immediately following the earthquake. Redwood planks were used for the temporary sills and stringers because larger timber was not quickly available.

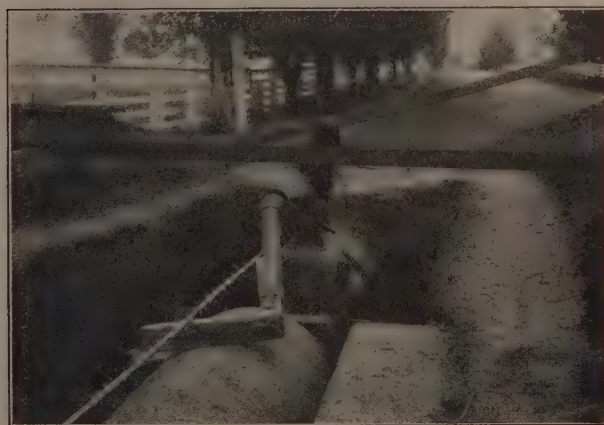
FIG. 33—Crystal Springs Conduit between San Mateo and Millbrae. Temporary Cut-Off to Stop the Flow of Water toward San Francisco and Yet Maintain a Pressure and Supply for the City of San Mateo.

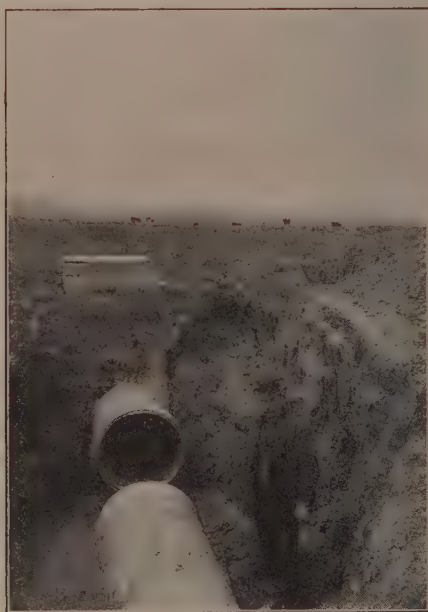
FIG. 34—Rupture on Pilarcitos Pipe Line near North End of San Andreas Reservoir.

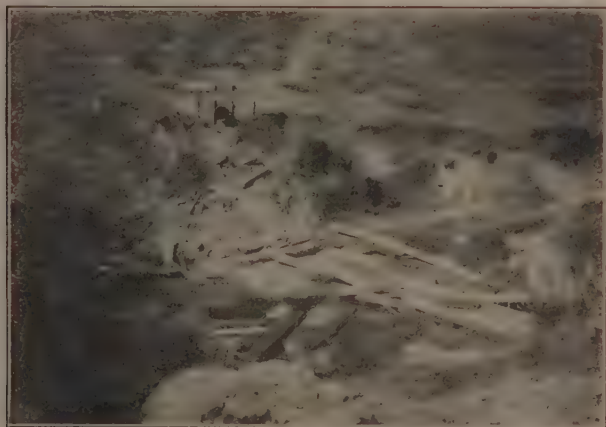
FIG. 35—Collapsed Trestle at Frawley Gulch, Pilarcitos Pipe Line, Spring Valley Water Company.

about 100 feet in length and some 25 feet in maximum height. Some of the timbers of this trestle were partly decayed, but the structure certainly was not weak. This trestle was about  $\frac{1}{4}$  mile to the east of the fault line. Nevertheless the shock was so severe that it entirely demolished the trestle and pipe which it carried. The trestle probably vibrated in a vertical plane normal to its length,

and was thrown down-stream to the southeast, as shown in Fig. 35.

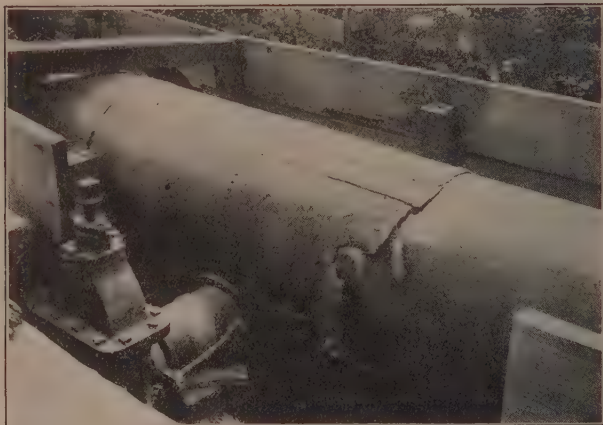
FIG. 36—*Telescoped Rupture, Pilarcitos Pipe Line, Spring Valley Water Company.*

supported on a timber framing, crosses a small swale. The pipe was telescoped 41 inches, and the blow-off valve connection was partly ripped from the conduit. Fig. 37 shows two ruptures a little

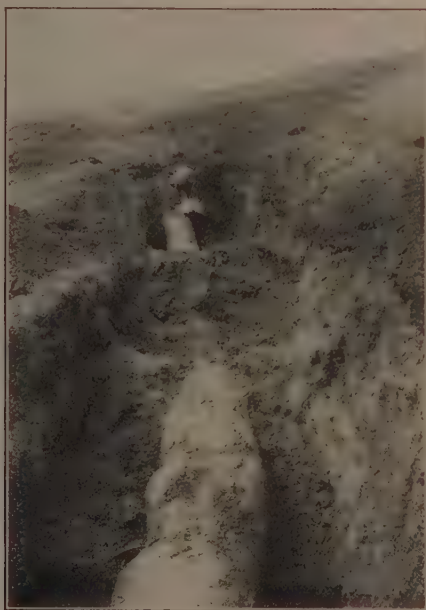
FIG. 37—*Diagonal Ruptures, Pilarcitos Pipe Line, Spring Valley Water Company.*

to the north of the break in Fig. 36. At the point where the man is standing the fault line crosses the pipe line at an angle of  $45^{\circ}$ . The pipe was sheared so that its parts are 20 inches out of alignment, and are moved toward each other 40 inches.

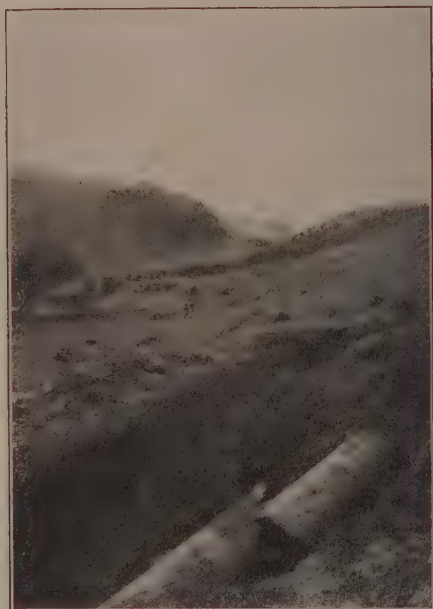
FIG. 38—*Diagonal Rupture, Pilarcitos Pipe Line, Spring Valley Water Company.*

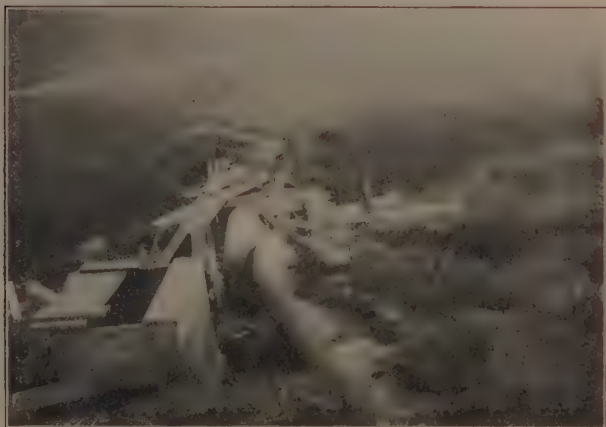
*FIG. 39.—Collapse by Compression at a Small Trestle, Pdarcitos Pipe Line, Spring Valley Water Company.*

Fig. 38 is a closer view of the same rupture. Fig. 39 shows the pipe crossing a small gulch. The blow-off valve situated at this point was stripped from the pipe and thrown ten feet. The pipe was telescoped 49 inches and thrown out of alignment, as shown. This rupture strikingly shows that the pipe metal was of high quality.

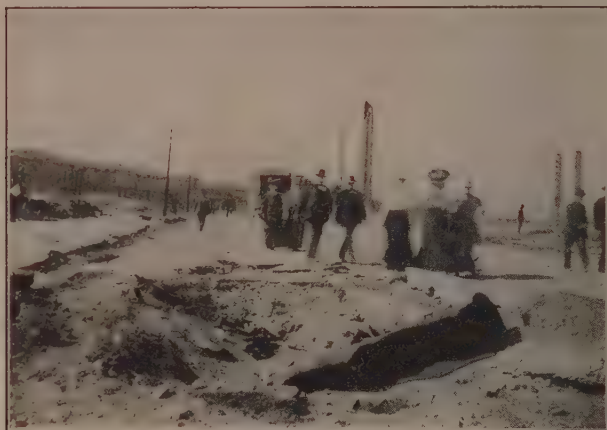
FIG. 40—Gas Main Explosion, Valencia Street, near Market Street, San Francisco.

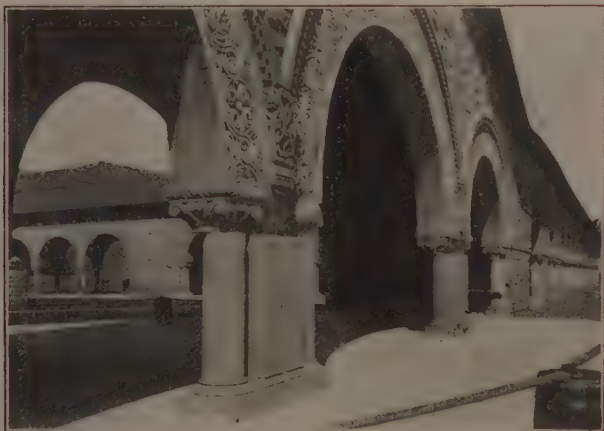
FIG. 41—Arcade, Inner Quadrangle, Stanford University.

tion. I consider the third reason by far the most important. Heavy stone-faced buildings of the type we find at Stanford, no matter how well built, cannot resist an earthquake of the intensity experienced at Palo Alto, when we consider the nature of the ground upon which the buildings rest. Top-heavy stone arcades and walls, supported by light masonry pillars, see Fig. 41, are not constituted to

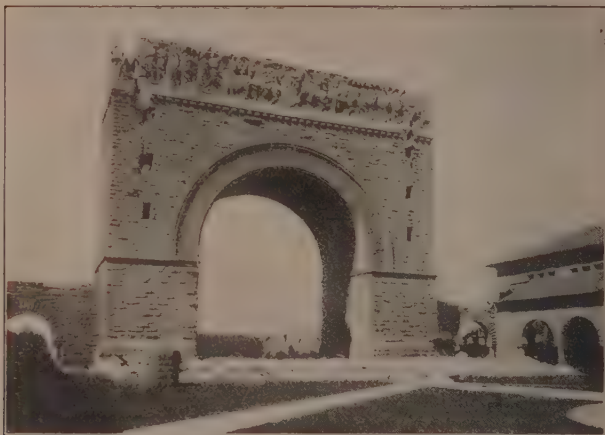
FIG. 42—Rear View Memorial Arch, Stanford University, Showing Arch Ring Intact.

I have seen many pictures of the Memorial Arch showing dramatic destruction. These pictures give a false impression. Fig. 42, a view of the rear elevation, shows that the arch ring itself was not thrown down; in fact, there were but a few cracks in the crown of the soffit. It was the heavy top and cornice, insufficiently tied, that fell, as they should. It would have been surprising had they not fallen. Above the arch was a large box-shaped mass of masonry upon which rested the heavy overhanging cornice, and this box had practically no transverse framing or partition walls of any kind. The masses that dropped from the arch fell in large pieces, nearly 100 feet to the pavement without crumbling, Fig. 43, which proves that the mortar was good. Considerable cement was used in the mortar for the

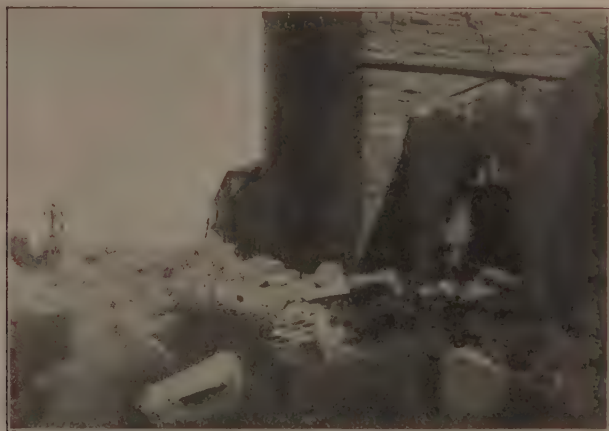
FIG. 43—*Fallen Masonry from Top of Memorial Arch, Stanford University, Showing Mortar Strength.*
